May 10, 1928

Engineering News-Record

St. Francis Dam—Facts and Findings Concerning the Failure. A Summary by N. A. Bowers. Also Abstracts of Reports by Four Boards of Engineers and Geologists

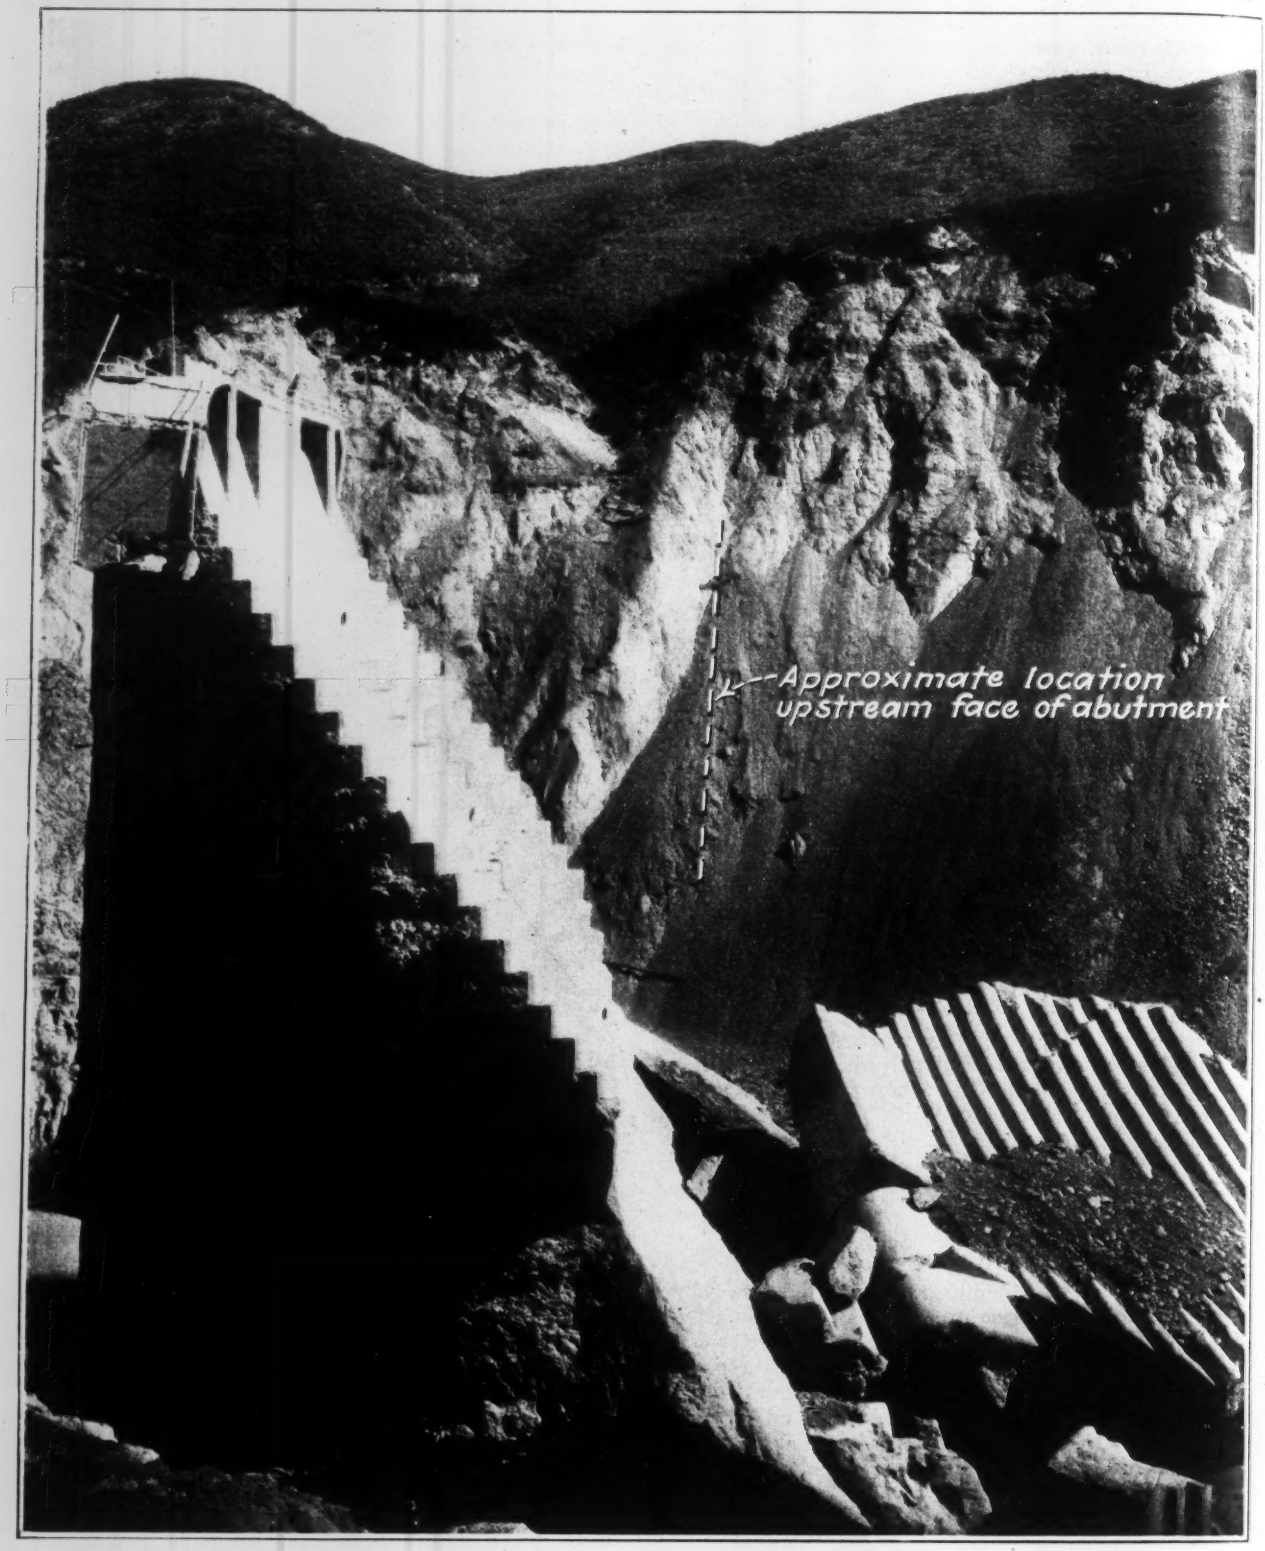
St. Francis Dam—Standing Portion and Right Bank After Failure

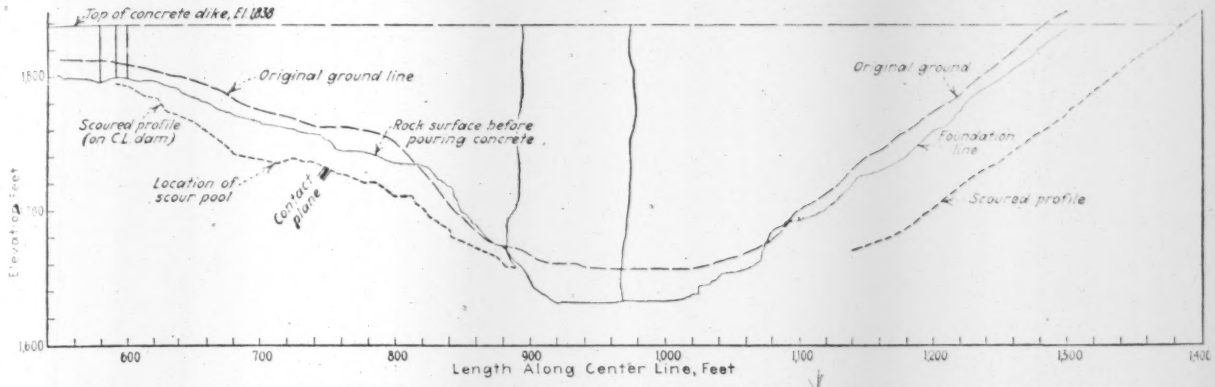
FIG. 2—ORIGINAL AND PRESENT CROSS-SECTIONS OF SAN FRANCISQUITO CANYON AT SITE OF DAM
Roughness of the original stadia survey from which the ground line was plotted is assumed to be responsible for the obvious errors which place the ground line below the dam foundation line at two points.

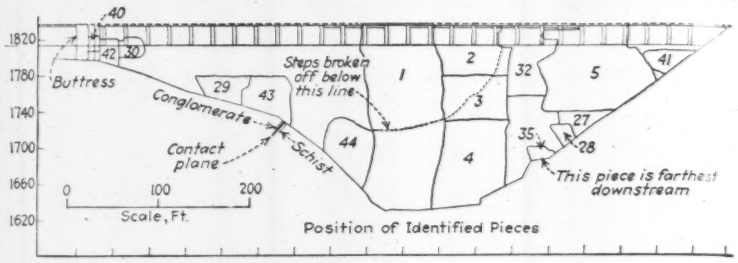
FIG. 4—LOCATION OF FRAGMENTS, AND ORIGINAL POSITIONS OF IDENTIFIED PIECES

The Break-Up of the Dam—Wherever the initial break is assumed to have occurred, the first block of concrete to move out was probably in contact with the foundation. Any cantilever action or arching of unsupported parts of the dam would concentrate excessive loads and moments on such parts as remained in place. Such excess stresses must have occurred at least momentarily in the section that still remains standing. On the other hand, when these stresses came it is probable that the effective height of water pressure behind the dam had been materially lessened, because, even if there had not yet been time to draw down the reservoir, there would have been a material drop in level close to the break caused by velocity head. Evidence of the steep downward curve of the escaping stream appears in the flood mark on the right bank just below the dam, where a man might have stood safely all through the break-up, at a point 70 ft. below the full reservoir level.

Piece 43 had adhering to its upturned base schist, black gouge and conglomerate, all in close proximity, thus locating it definitely as coming from the contact plane in the right bank.

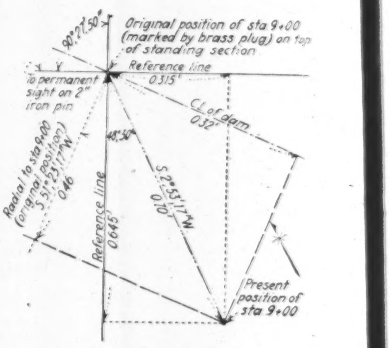
Original position of sta 9+00 (marked by brass plug) on top of standing section
Reference line
To permanent sight on 2" iron pin
CL of dam
Present position of sta 9+00

A resurvey after the break tying in to a hub on top of the standing portion indicated (Fig. 6) a displacement of 0.7 ft. Two other points located part way down on the downstream face indicated lesser movement here, which tends to show that such slight change in position as there was consisted of twisting and tilting rather than any sliding on the base. This is still a moot question; one geologist claims to have found indication of sliding at the base of the standing portion. In view of the terrific wrenching evidenced by the two sheared faces, however, it is remarkable that more movement did not occur.

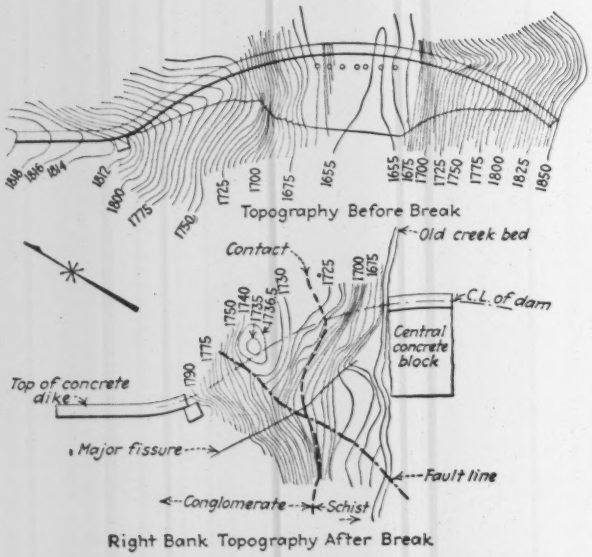
Scour and Movement—Resurvey of the site showed that erosion on the left bank has extended 55 to 60 ft. below original foundation levels, and at that the surface is so covered by sliding material that the actual rock face cannot be determined. Renewed speculation regarding the sequence of the failure was aroused when piece 35 from the left bank was identified as the one farthest downstream. This is the more puzzling because all large fragments on this side remained within the breach.

FIG. 5—WEST BANK TOPOGRAPHY AT DAM SITE, BEFORE AND AFTER

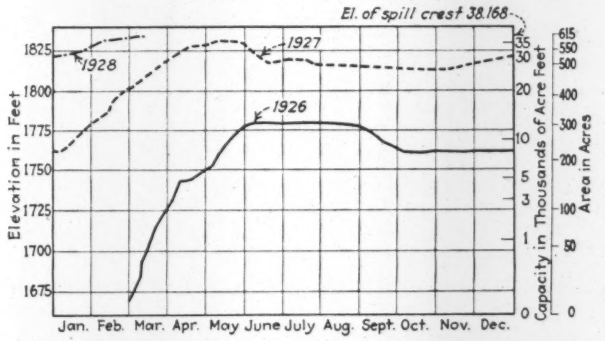
Seepage—The dam was completed in May, 1926, two months after storage had begun. In 1927 the reservoir was nearly filled, but it did not remain at that level (see storage record, Fig. 8). The failure on March 13, 1928, occurred almost immediately after the first complete filling.

FIG. 8—RECORD OF STORAGE IN ST. FRANCIS RESERVOIR

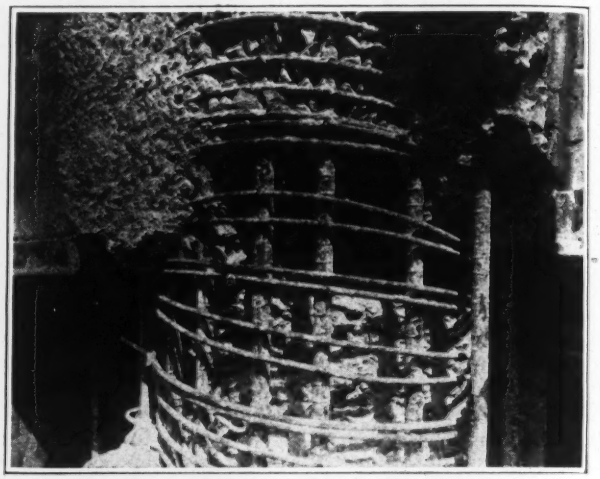
FIG. 2—CAVITY IN COLUMN UNDER SPANDREL BEAM

Column Defects—Where very wet or very dry undersanded concrete was poured in wall columns, the bottom

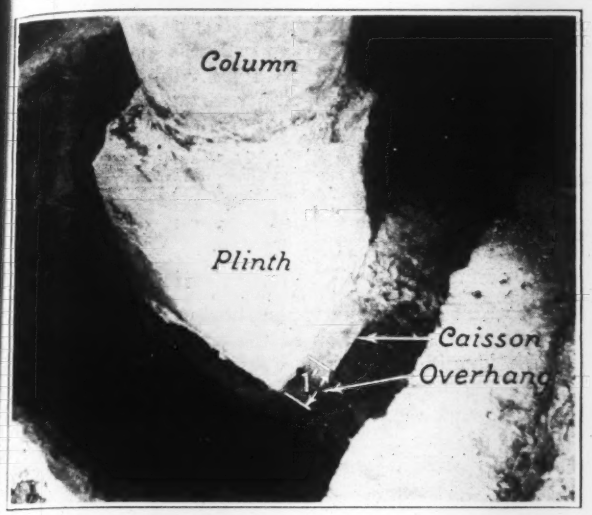
FIG. 3—COLUMN PEDESTAL ECCENTRIC ON FOUNDATION CAISSON

The first caisson uncovered was found to have this plinth overhanging the edge of the caisson so far that the side of the round column was 3½ in. outside the face of the caisson, as shown in Figs. 3 and 4, making an eccentricity of 20½ in. No dowels tied the plinth to the caisson, and when the latter was cut away, a smooth laitance-covered surface was left, showing that there had been no bond between the two. A test pit dug beside this caisson revealed that it did not extend to bedrock as shown on drawings and as certified by the builder, but stopped on a soft white chalk formation inadequate for the loads it was designed to carry. Test pits were subsequently dug beside the other caissons, and in no instance was a safe foundation found to have been built. A total of fifteen columns were shored up, the old concrete caissons removed and new caissons poured underneath them.

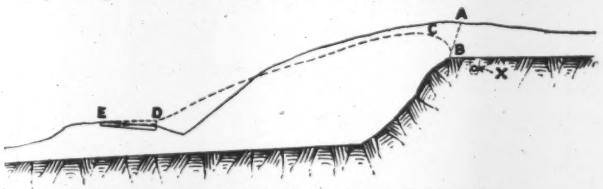
FIG. 1—TYPICAL SIDEHILL SLIP ABOVE ROAD
The first indication is usually a crack along *AB*. The material between *CB* and the road then gets into motion and the surface assumes position *CBDE*, quite often raising the pavement as shown at *DE*. Such a slip can be stopped by collecting water in trench as shown at *X* and leading it around slip in controlled channels.

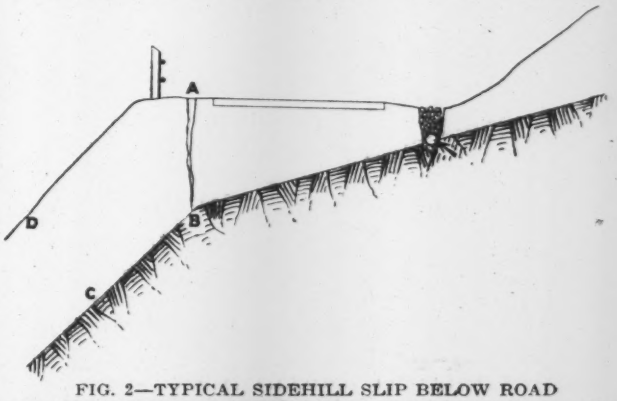
FIG. 2—TYPICAL SIDEHILL SLIP BELOW ROAD
The first indication is usually a crack occurring on the line *AB*. The material *ABCD* soon slips away and gradually slips from under the pavement. The beneficial results obtained by installation of drainage system as shown are usually apparent within 24 hours of installation. The material *ABCD* will cease to move within a few days, and backfilling to return shoulder to its original cross-section can be put in.
